GAMMA SCANNING TECHNIQUE FOR INVESTIGATING DE-ETHANIZER COLUMN: ON FIELD EXPERIMENTAL AT NGL PLANT

Gamma scanning technique was used to examine the 01-C-3401 de-ethanizer column of

NGL company in North Sumatera, Indonesia. The unit is a trayed column with the inside diameter of 1900 mm at the lower segment, 3200 mm at the upper segment, and the total height of 36710 mm (TL to TL) with lower segment height is 27210 mm and upper segment height is 9500 mm. The number of the trays is 38 with 30 trays in the lower segment and 8 trays in the upper segment.

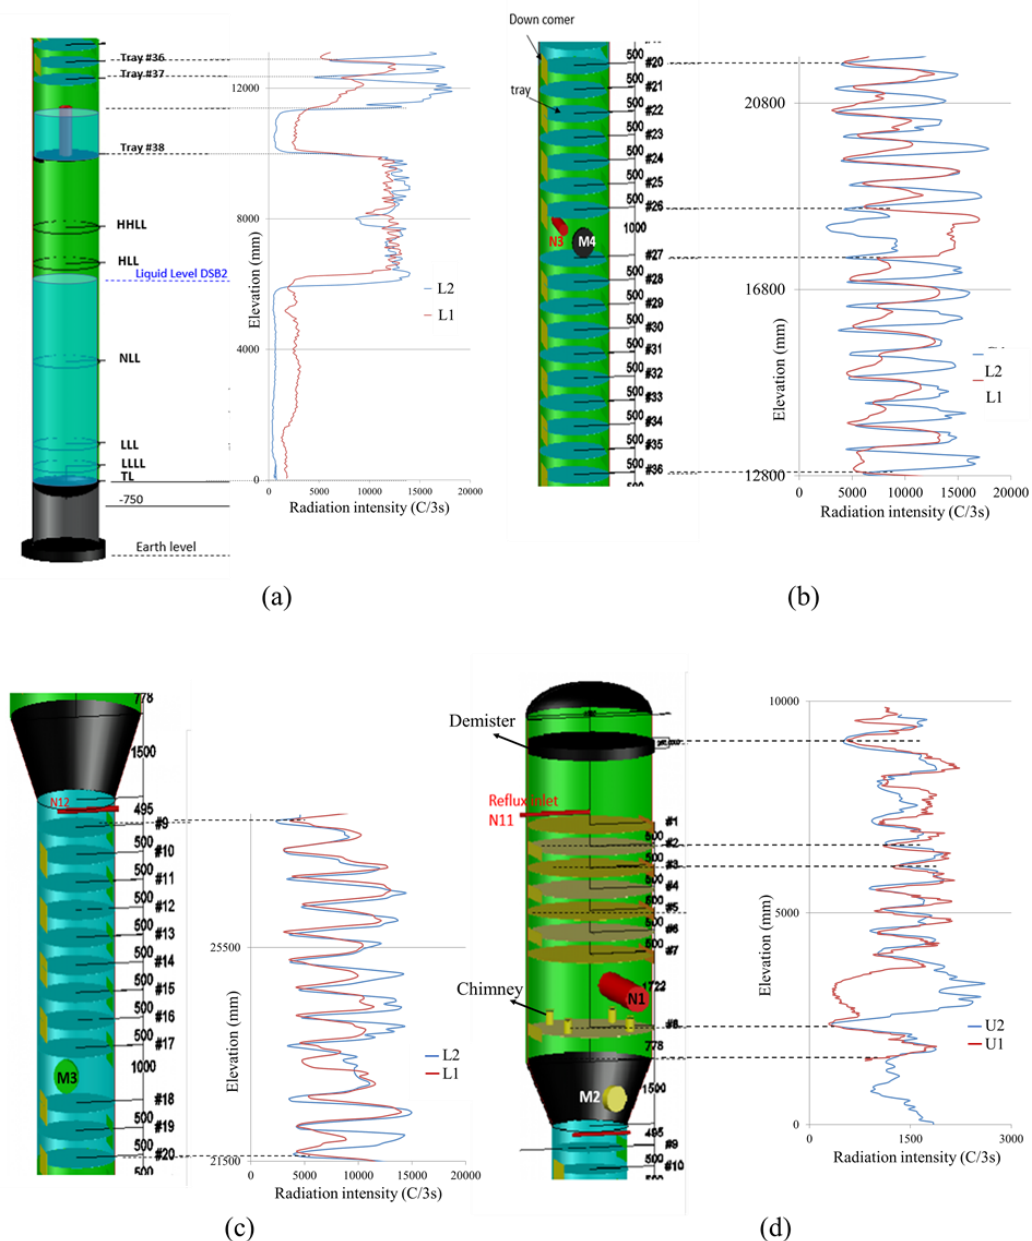
Figure 3. Scan data, (a) lower segment TL-tray #36, (b) lower segment tray #36-#20, (c) lower segment tray #20-#9, and (d) upper segment tray #8-demister.

The results show the mechanical structure of tray #1 until tray #38 were in their position indicated by the profile of scan data, the radiation intensity was always becoming extremely lower at trays elevation than void positions. It was caused by trays material and liquid above it absorbed the gamma radiation. Overall, the gap between trays are 500 mm except between tray #38 and tray #37 (2200 mm) caused by chimney, between tray #27 and tray #26 (1000 mm) caused by manhole “M4” and Nozzle “N3”, between tray #18 and tray #17 caused by manhole “M3”, between tray #9 and tray #8 caused by bottleneck shape, and between tray #8 and tray #7 caused by chimney and nozzle “N1”. The patterns of the scan

The liquid level above trays was in the normal condition indicated by shapes tray scan profiles, overall the trays profiles thickness was symmetric. There were no thicker profiles. Thicker tray profile means the possibility of foaming. There were weeping bellow tray #9 and #10 as shown in Figure 3 (c). Weeping is the presence of downward droplets in the vapor space between trays.

There were no collapsed or flooded trays in the column. Figure 3 shows there were no collapsed structures in the column. The collapsed trays or other internal structures can be observed by dissimilar patterns of the trays profile (i.e. missing tray) or observing unknown material above another tray. Flooded tray phenomenon could be known by liquid level conditions above the tray. The flooded tray can be caused by unknown material blocked the downcomer channel.

The scan profile of L1 was not so good as shown in Figure 3 (b). There are so many obstacles to that position that caused the line become inconsistent. The improper scan data might cause by gamma beam to hit the downcomer. However, the data were complemented and supported by data L2 because they hit the same tray (single pass tray).

Chimneys above tray #38 and tray #8 were observed exist. The chimney above tray #38 was observed at data L1 and L2 as shown in Figure 3 (a). Chimney made liquid accumulated as high as its height. Furthermore, chimney above tray #8 was observed at data U1 and U2. the thicker shape of tray #8 indicated the chimney has existed. The unsymmetric of scan profile between U1 and U2 above tray #8 caused by the U1 was hit the reinforcement of nozzle “N1”.

Based on data U1 and U2 in Figure 3 (d), the demister can be stated in its position. The total thickness of the demister is 250 mm. the existence of a demister is important to prevent liquid particles from being brought to the top product.

The liquid level during the scanning process was in normal liquid level (NLL) approaching to high liquid level (HLL). Based on Figure 3 (a), the liquid level on data L1 is 6150 mm above TL and L2 is 5850 mm above TL. While the normal liquid level (NLL) of-

the column is 3500 mm and a high liquid level (HLL) is 6350 mm above TL. The time gap between data L1 and L2 is one day.
