## FAILURE ANALYSIS OF ALUMINIUM AND ZINC HEAT REFLECTOR IN TIMBER DRY KILN

Aluminium and Zinc (Al-Zn) alloy coated steel sheet (JIS G3141) was used as a heat reflector in timber dry kiln. After six months continuous service at 110°C in moist condition, the heat reflector is corroded. Failure analysis method was used to analyze this corrosion phenomena. Macroscopic and microscopic examination with some characterization have been performed to determine the elemental composition and corrosion products. The elemental composition of corroded heat reflector that were detected by SEM-EDS are sulphur, chloride, calcium, and potassium. XRD analysis revealed the zinc aluminium carbonate hydroxide hydrate ( $Zn_6Al_2(OH)_{16}CO_3 \cdot 4H_2O$ ) known as black rust staining and iron oxide ( $Fe_3O_4$ ), as corrosion products. Environmental condition in timber dry kiln with the existence of acid and alkaline elements cause the corrosion process occur. Those elements come from the dried timber and steam that adhered on the heat reflector surface attacked the Al-Zn coating and base metal. Humidity and high temperature in timber dry kiln environment increase the corrosion rate of the heat reflec

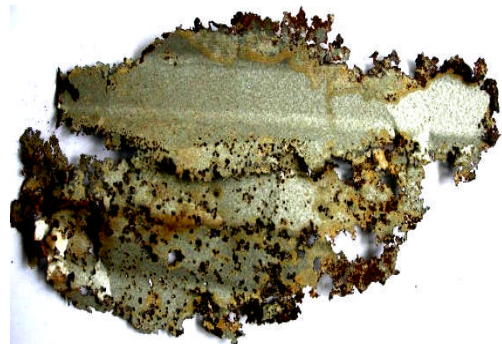
The temperature of the kiln is 110 °C and the kiln was operated in 24 hours non stop. Aluminium and Zinc (Al-Zn) alloy in this kiln to function as a sub ceiling. This ceiling was used as a heat reflector in order to isolate the heat and the heat can be reflected back to the timber. Kind of wood that was dried in timber dry kiln is Sengon wood. After six months continuous service, the Al-Zn heat reflector was corroded and rusty. Figure 1 showing the corroded and rusty Al-Zn alloy that was used as heat reflector.

Figure 1. The corroded Al-Zn heat reflector.

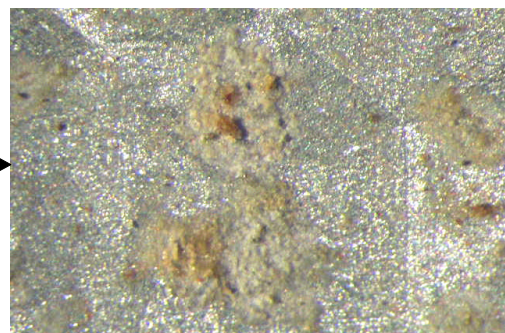
Observation by using digital camera showed that the surface texture was relatively rough and thin particularly at the edge of the sample, see Figure 2.

Figure 2. Photograph of surface exhibit the deposit around the perforated area (a) and exhibit the corrosion product seems like deposit (b).

It can be seen that the thin of the sample also followed by the existence of dark-brownish perforated area. It means the Al-Zn coating at the sample's edge has flaked off and corrosion products were observed around the perforated area on the surface. In the contrary, the visible of spangle in the middle of sample proves that Al-Zn alloy still remain. Observation of corrosion products can be clearly seen by using stereomicroscope. They adhered on the surface layer of the sample seems like deposit. [12,13].

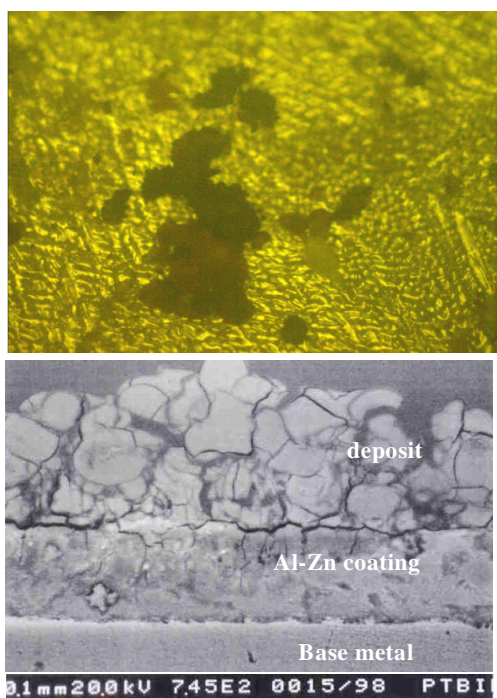
Figure 3 showing the microstructures of Al-Zn coating surface that was used as a heat reflector and corrosion deposit observed at cross section. The coating on the surface still remain intact but there is corrosion deposit adhered on the above of coating, it appear as somewhat dark reddish stain. The existence of deposit obviously detected by SEM.

Figure 3. Surface (left, 200X) and cross section microstructures of Al-Zn heat reflector.

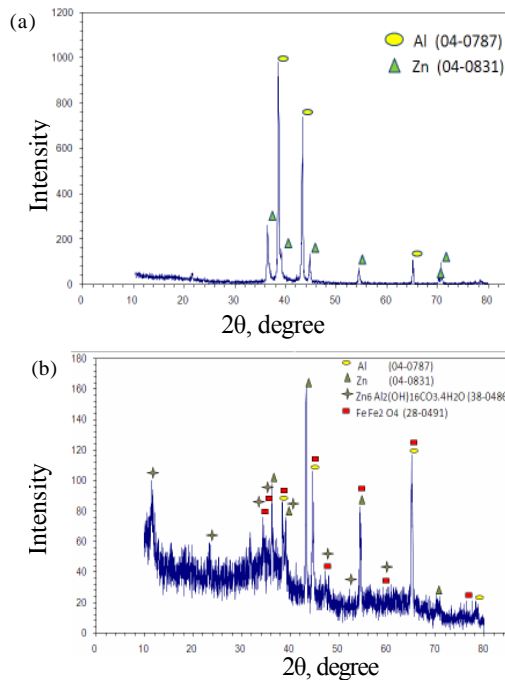
Phase analysis by using X-Ray Diffraction (XRD) in Figure 4 revealed compounds that contain in heat reflector consists of coating composition just like the fresh sample, they are Al-Zn as a strongest peak. Small amount of iron oxide ( $Fe_3O_4$ ) and Zinc aluminum carbonate hydroxide hydrate ( $Zn_6Al_2(OH)_{16}CO_3 \cdot 4H_2O$ ) were also identified in the corroded heat reflector. The latter phase is predicted as dark reddish corrosion deposit that adhered on the coating.

Figure 4. XRD pattern of (a). fresh sample Al-Zn coating and (b). corroded Al-Zn heat reflector

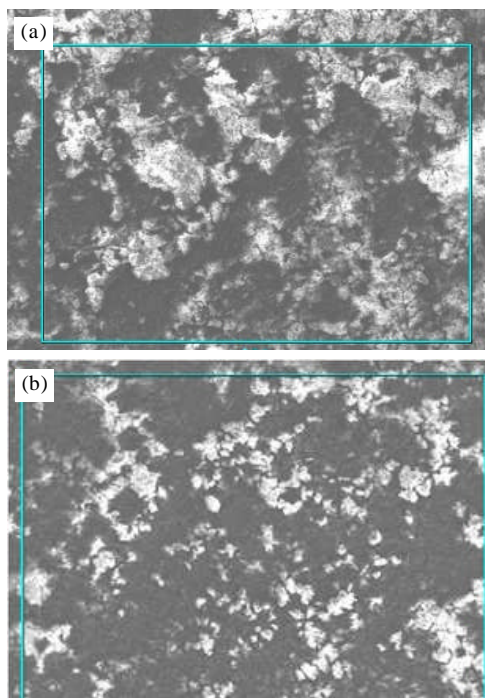
Figure 5. Square analysis of corroded Al-Zn heat reflector.

Table 1. Chemical composition of square area in Figure 5

Element (wt.%)	Square Area 1	Square Area 2
C	18.34	10.34
O	38.84	43.15
Al	10.09	17.87
S	1.82	0.73
Cl	0.62	1.70
Ca	3.91	1.44
K	--	0.09
Fe	3.82	0.91
Zn	21.17	23.62

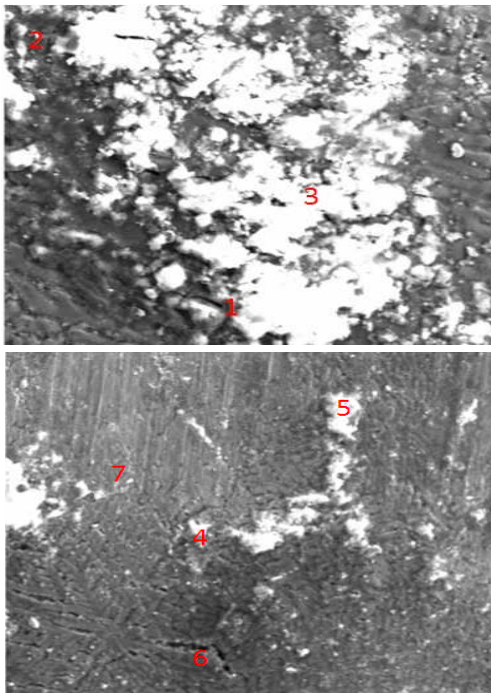
Figure 6. Point analysis on the corroded surface Al-Zn heat reflector.

Table 2. Chemical composition for every point in Figure 6

Element (wt.%)	Points						
	1	2	3	4	5	6	7
C	13.13	16.30	28.51	13.54	12.67	67.58	34.27
O	48.58	31.13	37.56	33.57	40.18	3.77	7.16
Al	15.48	2.99	5.85	14.60	12.61	9.69	21.53
Si	---	3.97	---	3.25	0.49	0.24	0.09
S	1.28	1.59	3.78	0.44	---	---	---
Cl	1.75	5.98	0.82	---	---	---	---
Ca	0.84	0.80	0.59	2.09	1.83	0.03	0.09
Fe	0.51	1.30	1.02	12.48	8.39	0.27	0.60
Zn	17.95	35.93	21.86	19.65	22.04	18.21	36.22
K	0.49	---	---	---	---	---	---

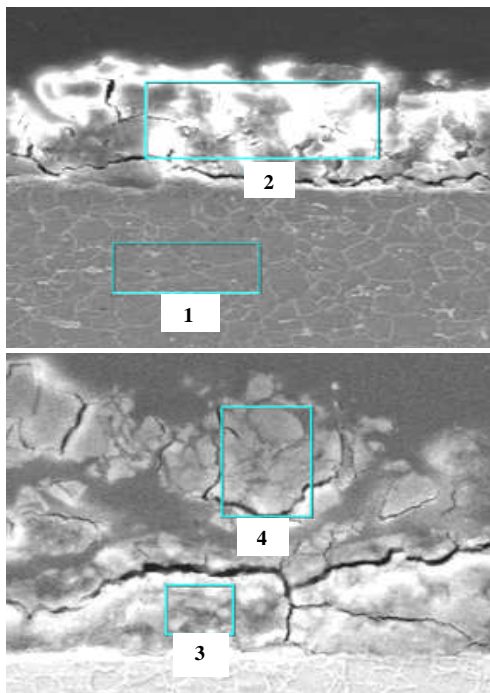
Figure 7. Square analysis at the cross section of corroded Al-Zn heat reflector.

Table 3. Chemical composition of square area analysis in Figure 7

Element (wt.%)	Square Area			
	1 Base metal	2 coating	3 coating	4 deposit
C	2.27	30.47	19.34	22.46
O	0.41	35.36	34.13	43.69
Al	---	13.30	22.49	18.77
Si	0.09	1.12	2.92	0.32
S	---	0.97	1.18	1.47
Cl	---	---	0.56	0.12
Ca	---	0.55	---	1.64
Fe	97.23	0.89	1.52	0.37
Zn	---	17.25	17.86	11.16
K	---	0.09	---	---

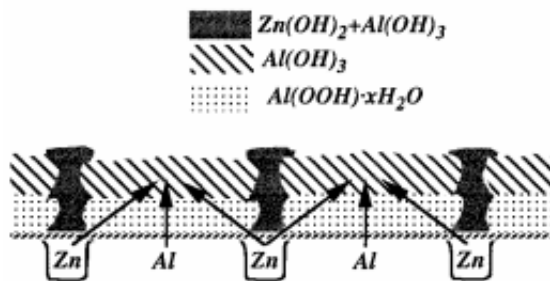
**Figure 8.** Formation of corrosion products in Al-Zn heat reflector.

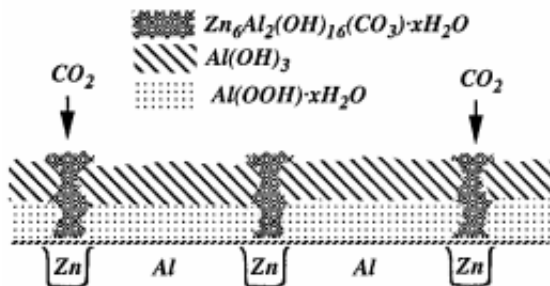
**Figure 9.** Formation of corrosion products of corroded Al-Zn heat reflector on the underside surface in contact with air.
