### OXIDE LAYER CHARACTERIZATION OF AlMg<sub>2</sub> CLADDING OF IRRADIATED U<sub>3</sub>Si<sub>2</sub>/Al FUEL WITH 4.8 gU/cm<sup>3</sup> DENSITY

**OXIDE LAYER CHARACTERIZATION OF AlMg<sub>2</sub> CLADDING OF IRRADIATED U<sub>3</sub>Si<sub>2</sub>/Al FUEL WITH 4.8 gU/cm<sup>3</sup> DENSITY.** To investigate the performance of AlMg<sub>2</sub> cladding in the U<sub>3</sub>Si<sub>2</sub>/Al dispersion fuel, oxide layer characterization of AlMg<sub>2</sub> cladding of the irradiated U<sub>3</sub>Si<sub>2</sub>/Al fuel with 4.8 gU/cm<sup>3</sup> density was conducted. The oxide layer on the surface of AlMg<sub>2</sub> cladding is one of the changes that occur on the cladding after the U<sub>3</sub>Si<sub>2</sub>/Al fuel plate has been irradiated in the RSG-GAS reactor to a burn-up of ~40%. The characterization and observation of the oxide layer was conducted using SEM (Scanning Electron Microscope) and Energy-dispersive X-ray spectroscopy (EDS). Samples with a size of 3x3 mm were taken from the middle of the fuel plate (middle position). After cutting, metallographic preparation includes mounting, grinding, polishing, and ultrasonic cleaning. SEM preparation was carried out by sputte

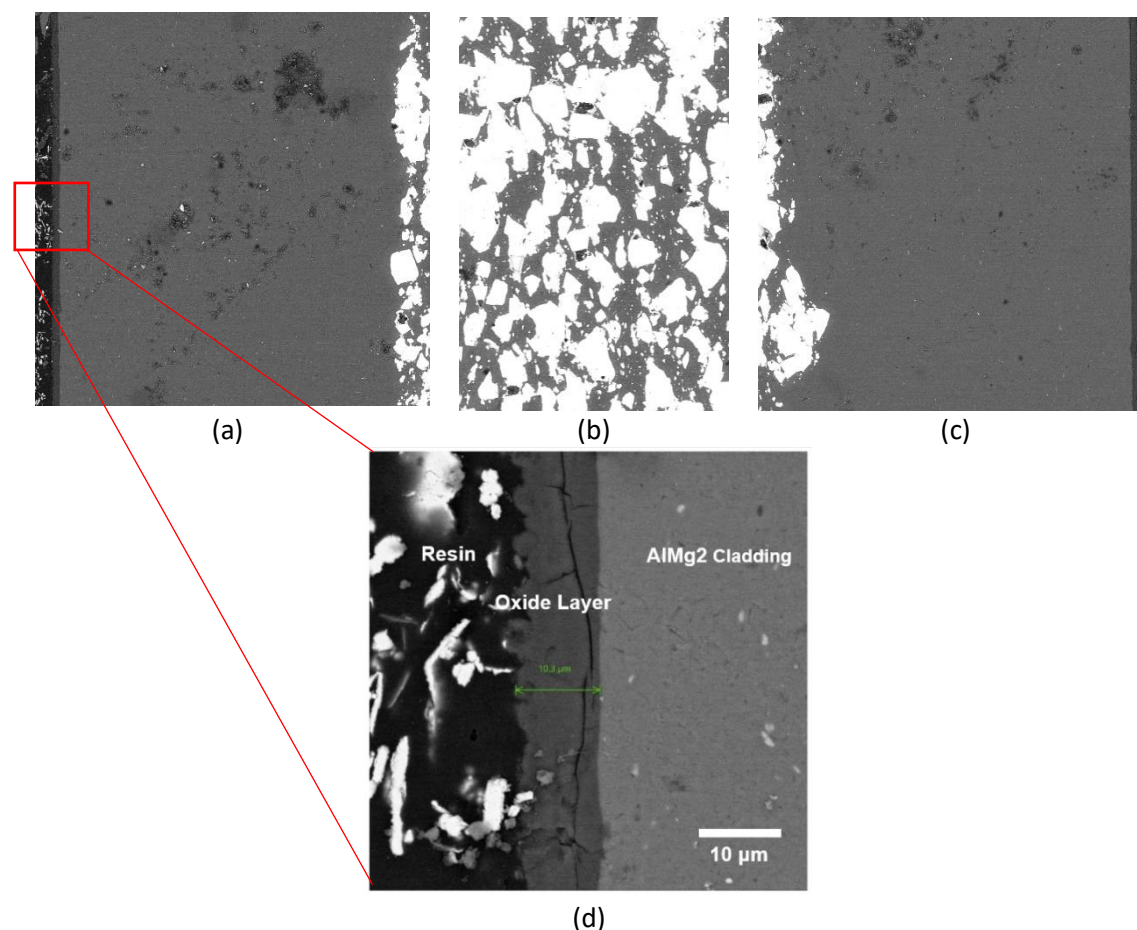
The low magnifications ceramography observations of the fuel cross-section shows the oxide layer on both outer cladding surfaces of the AlMg<sub>2</sub> cladding as shown in Figure 2(a)-(c). The detailed image of the oxide layer is shown in Figure 2(d). The formed oxide layer looks dense, non-porous, and no granular aspect appearance so that pitting corrosion is unlikely to occur, in contrast to the pitting corrosion observations by Leenaers [22] as shown in Figure 3. In Figure 2(d), the cracks are clearly visible along the oxide layer. Similar cracks on the oxide layer were also observed in the other studies [23], [26] as depicted in Figure 4. Leenaers et al [23], observed that the cracked oxide layer did not firmly attach to the irradiated AlFeNi cladding and can be removed easily. The crack pattern, as depicted in Figure 4(c), were suggested to be caused by dehydration (evaporation of the lattice water) of the oxide layer during the drying of the fuel element in the hot cell. Wintergest et al [26], who studied the corrosion product of unirradiated AlFeNi alloy obtained from autoclaves, also observed similar cracks on the oxide layer, stating that the cracks can be formed during mounting or mechanical polishing, or because of the growth stresses or thermal stresses.

The oxide layer observed in Figure 2 (d) appears as a single layer. Based on the literatures, the oxide layer on Al-based alloy cladding typically consists of all or some of protective oxide of alumina and oxide-hydrates boehmite and bayerite layer [21], [22]. Boehmite and bayerite formed in the outer surface by degradation of the alumina in the water [21]. The removed oxide layer characterized through XRD [23], also showed two major constituents of boehmite and bayerite. The temperature condition seems to affect the morphology and phase formation of the oxide layer [26]. Semi-quantitative element identification with EDS linescan showed that the layer mainly consists of Al and O atoms (Figure 5).

The thickness of the oxide layer measured using SEM image analysis software was approximately 10.3  $\mu$ m. The oxide layer formed is very thin and therefore did not change the integrity of the AlMg2 cladding. As a comparison, the thickness of the AlMg2 cladding required for use in the reactor is 0.25 mm. In Leenaers' work [23],

Figure 2. Backscatter electron SEM Image of the irradiated fuel plate over the width (cross-section), showing overview of the fuel cross-section (a-c); and more detailed micrograph of the oxide layer on the fuel cladding (d).

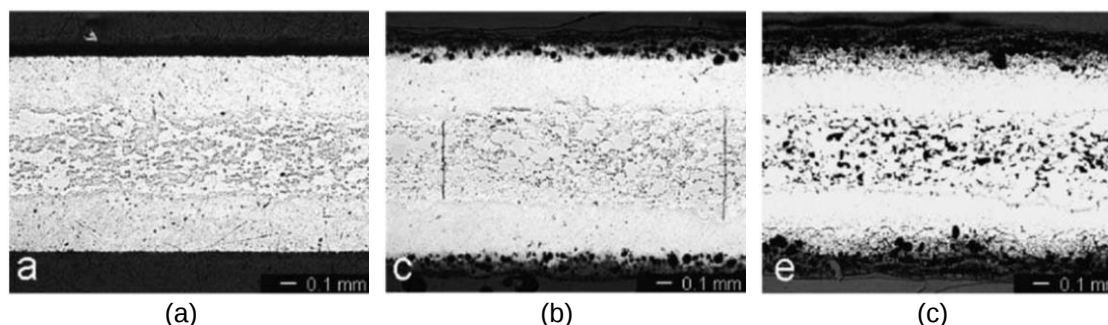
Figure 3. Image of the cross-section of the fuel plate submitted to  $\sim 450$  W/cm<sup>2</sup> (a);  $\sim 500$  W/cm<sup>2</sup> (b); and  $\sim 550$  W/cm<sup>2</sup> (c) from Leenaers' work [22], showing granular aspect of pitting corrosion on the Al5754 alloy cladding.

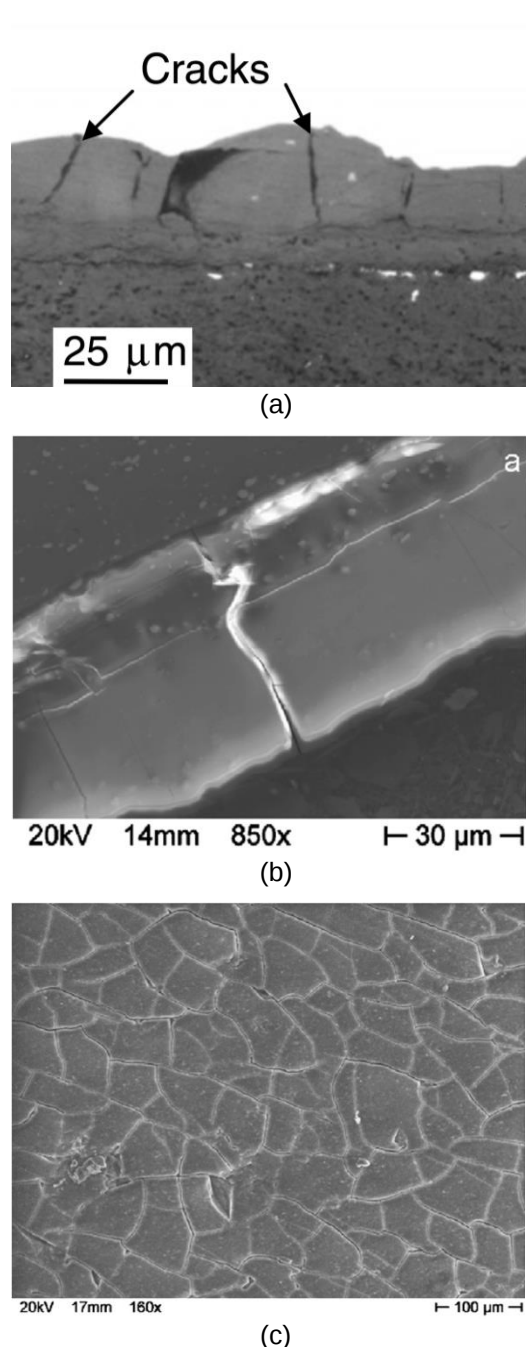
Figure 4. Micrograph showing cracks in the oxide layer of fuel cladding: AG3NE cladding in SIMONE LC-04 fuel test [21] (a), and; AlFeNi cladding from  $U_3Si_2$  fuel [23] cross section (b) and surface (c).

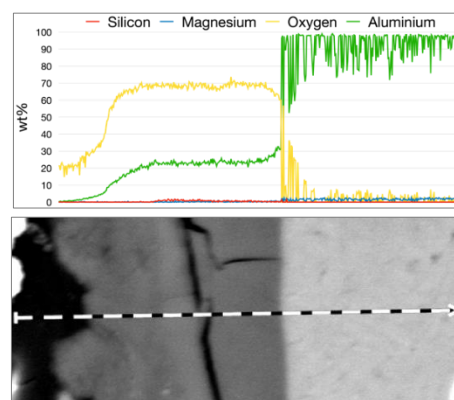
Figure 5. Semi-quantitative linescan covering the AlMg2 cladding and the oxide layer.
