## **RADIOGRAPHIC EXAMINATION OF PRESSURED PARTS FOR HEAT RECOVERY STEAM GENERATOR**

**Amiral Aziz**

This paper discuss some result of the radiography test that were carried out to examine the welding results of the site construction of Heat Recovery Steam Generator Piping of Tanjung Priok Gas Fired Power Plant Extension Project

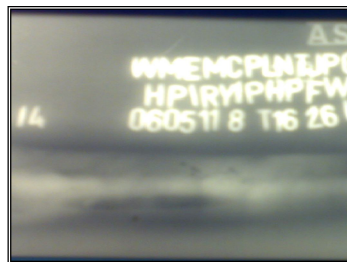
Figure 3. Radiographic image of field specimen No 1 (HP 1 RY SH inlet pipe) - incomplete penetration and WH

should be repaired. Specimen no 1 also have Incomplete Penetration and Worm Holes defects at joint No F17 as are shown in figure 3. The slag inclusion often associated with undercut, incomplete penetration and lack of fusion in welds. Insufficient cleaning between multi-pass welds and incorrect current and electrode manipulation can leave slag and unfused sections along the weld joint. Slag inclusions not only reduce cross sectional area strength of the joint but also may serve as an ignition point for serious cracking. Incomplete penetration (IP) defect as shows Figure 3 is very dangerous, it occurred when the weld metal did not form a cohesive bond with the base metal to the required depth, resulting in insufficient throat thickness. This defect is usually caused by incorrect welding condition. The cumulative length on incomplete penetration is larger than 35 mm, therefore this results is rejected.

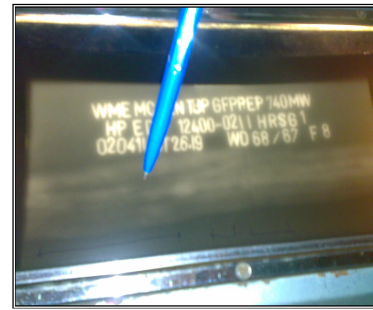
Figure 6. Radiographic image of field specimen No 4 (HP EVA Down commerce pipe) Incomplete fusion indication

The incomplete fusion found at joint No F08 of specimen No 4 as could be seen in figure 6 and Table 7. This welding imperfection is rejected, because a cumulative length of lack of fusion is larger than 38 mm. It is also found the incomplete fusion at joint No F27 of specimen No 5. The depth of lack of fusion is larger than 0.2 of the thickness of piping, hence needed to be repaired.

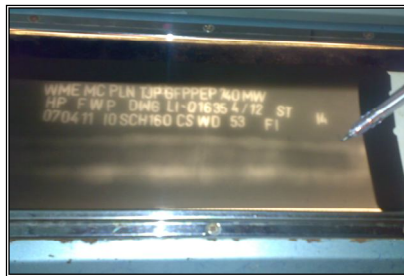
Figure 4. Radiographic image of field specimen No 2 (HP Feed water piping) -Internal concavity (IC) indications

The RT results of specimen No 2 are given in Figure 4 and Table 5. The specimen No 2 is HP Feed Water Piping of HRSG1. From Table 4 it may be seen that 3 joints were examined by Radiographic testing. The radiographic images in Figure 4 and 5 indicated the rejectable Internal Concavity occurred on specimen No 2 and 3 respectively. It is a condition where the weld metal has contracted as it cools and has been drawn up into the root of the weld. Internal Concavity (IC) also occurred on specimen No 5 as could be seen in Table 7.

of contamination or poor protection of the molten solidifying metal. It is generally accepted that porosity in weld metals is formed by the entrapment of evolved gases in the solidifying weld metal. The discontinuity formed is generally spherical but may be cylindrical. The joint no F04 and F06 of specimen No 2 have many defects especially Porosity and Slag Inclusion. These results are rejected because of acceptable value limits, therefore they are should be repaired

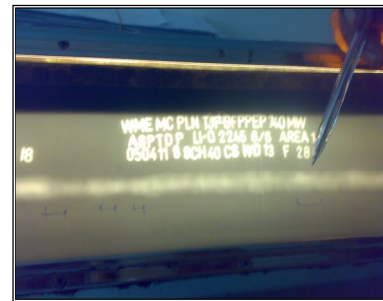
Figure 7. Radiographic image of field specimen No 5-Auxiliary steam piping HRSG1 Slag inclusion and cluster porosity

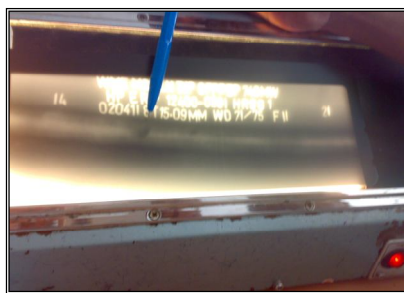
Figure 5. Radiographic image of field specimen No 3 (HP EVA RISER Pipe) - Internal concavity indication

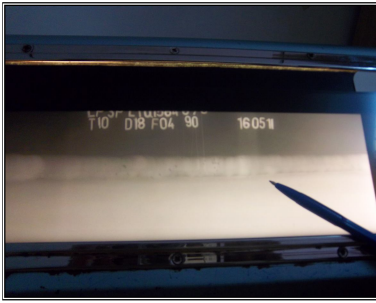
Figure 9. Radiographic image of field specimen No 7-LP steam piping slag inclusion and worm holes

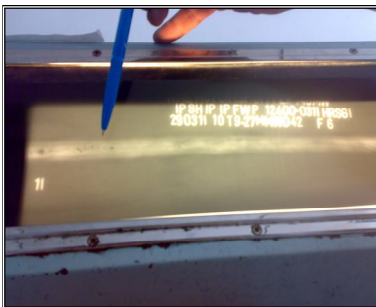
Figure 10. Radiographic image of field specimen No 8 - IP super heater inlet pipe & IP feed water pipe-worm holes

From figure 10 and table 11, it could be seen that the worm hole (WH) occurred at joint No F06 of specimen No 8. This specimen is the IP Super Heater Inlet Piping HRSG1 that is made from SA 106 B. It's diameter and thickness are 10 inch and 9,27 mm respectively. The worm hole is a form of pores that is roughly elliptical in shape and has its major axis normal to the advancing solidification wave. Where irregular shaped voids are present or where cavities occur in group, these are perhaps due to mechanical entrapped gas caused by arc instability.
