## **RADIOGRAPHIC EXAMINATION OF PRESSURED PARTS FOR HEAT RECOVERY STEAM GENERATOR**

**Amiral Aziz**

Centre for the Technology of Conversion and Conservation Energy, BPPT

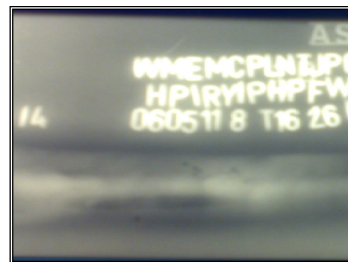
Figure 3. Radiographic image of field specimen No 1 (HP 1 RY SH inlet pipe) - incomplete penetration and WH

should be repaired. Specimen no 1 also have Incomplete Penetration and Worm Holes defects at joint No F17 as are shown in figure 3. The slag inclusion often associated with undercut, incomplete penetration and lack of fusion in welds. Insufficient cleaning between multi-pass welds and incorrect current and electrode manipulation can leave slag and unfused sections along the weld joint. Slag inclusions not only reduce cross sectional area strength of the joint but also may serve as an ignition point for serious cracking. Incomplete penetration (IP) defect as shows Figure 3 is very dangerous, it occurred when the weld metal did not form a cohesive bond with the base metal to the required depth, resulting in insufficient throat thickness. This defect is usually caused by incorrect welding condition. The cumulative length on incomplete penetration is larger than 35 mm, therefore this results is rejected.

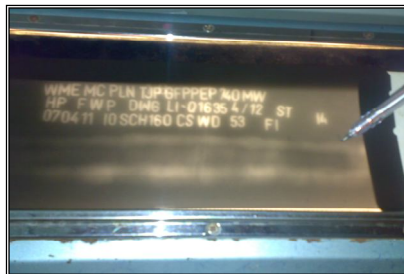
Figure 4. Radiographic image of field specimen No 2 (HP Feed water piping) - Internal concavity (IC) indications

The RT results of specimen No 2 are given in Figure 4 and Table 5. The specimen No 2 is HP Feed Water Piping of HRSG1. From Table 4 it may be seen that 3 joints were examined by Radiographic testing. The radiographic images in Figure 4 and 5 indicated the rejectable Internal Concavity occurred on specimen No 2 and 3 respectively. It is a condition where the weld metal has contracted as it cools and has been drawn up into the root of the weld. Internal Concavity (IC) also occurred on specimen No 5 as could be seen in Table 7.

of contamination or poor protection of the molten solidifying metal. It is generally accepted that porosity in weld metals is formed by the entrapment of evolved gases in the solidifying weld metal. The discontinuity formed is generally spherical but may be cylindrical. The joint no F04 and F06 of specimen No 2 have many defects especially Porosity and Slag Inclusion. These results are rejected because of acceptable value limits,, therefore they are should be repaired

Joint No	Welder stamp No	Film Location	Standard	Material	Thickness	Weld Defect	Remark
F01	053	7-14	ASME B31.3	C/S	Ø10" SCH 160	Internal Concavity	Repair
F04	052/083	0-7	ASME B31.3	C/S	Ø10" SCH 160	Porosity and Slag Inclusion	Repair
F04	052/083	7 - 14	ASME B31.3	C/S	Ø10" SCH 160	Porosity and Slag Inclusion	Repair
F04	052/083	14 - 21	ASME B31.3	C/S	Ø10" SCH 160	Slag Inclusion	Repair
F04	052/083	21 - 28	ASME B31.3	C/S	Ø10" SCH 160		Accepted
F04	052/083	28-0	ASME B31.3	C/S	Ø10" SCH 160	Slag Inclusion	Repair
F06	052/083	0-7	ASME B31.3	C/S	Ø10" SCH 160	Slag Inclusion	Repair
F06	052/083	7 - 14	ASME B31.3	C/S	Ø10" SCH 160	Porosity and Slag Inclusion	Repair
F06	052/083	14 - 21	ASME B31.3	C/S	Ø10" SCH 160	Slag Inclusion	Repair
F06	052/083	21 - 28	ASME B31.3	C/S	Ø10" SCH 160		Accepted
F06	052/083	28-0	ASME B31.3	C/S	Ø10" SCH 160		Accepted

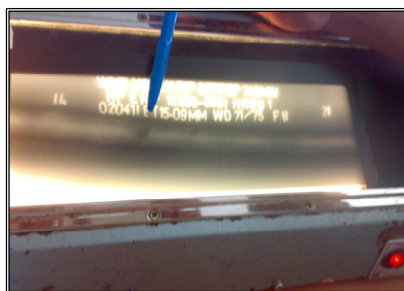
Figure 5. Radiographic image of field specimen No 3 (HP EVA RISER Pipe) - Internal concavity indication

Joint No	Welder stamp No	Film Location	Standard	Material	Thickness	Weld Defect	Remark
F05	068	0 -9	ASME VIII DIV 1	SA 106 C	Ø8" x 15,09 mm	Porosity 2 mm	Accepted
F05	068	9 -18	ASME VIII DIV 1	SA 106 C	Ø8" x 15,09 mm	Porosity and Slag Inclusion	Repair
F05	068	18 - 0	ASME VIII DIV 1	SA 106 C	Ø8" x 15,09 mm		Accepted
F11	071/075	0-7	ASME VIII DIV 1	SA 106 C	Ø8" x 15,09 mm	Porosity 1 mm	Accepted
F11	071/075	7 - 14	ASME VIII DIV 1	SA 106 C	Ø8" x 15,09 mm		Accepted
F11	071/075	14 - 21	ASME VIII DIV 1	SA 106 C	Ø8" x 15,09 mm	Internal Concavity	Repair
F11	071/075	21 - 0	ASME VIII DIV 1	SA 106 C	Ø8" x 15,09 mm		Accepted
F15	086	0-7	ASME VIII DIV 1	SA 106 C	Ø8" x 15,09 mm	Slag Inclusion 3 mm	Accepted
F15	086	7 - 14	ASME VIII DIV 1	SA 106 C	Ø8" x 15,09 mm		Accepted
F15	086	14 - 21	ASME VIII DIV 1	SA 106 C	Ø8" x 15,09 mm		Accepted
F15	086	21 - 0	ASME VIII DIV 1	SA 106 C	Ø8" x 15,09 mm	Accepted	Repair

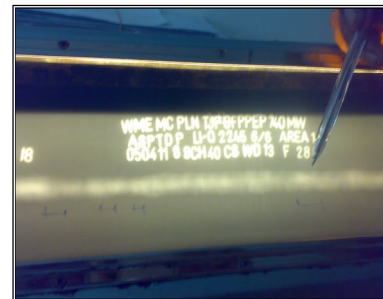
Figure 7. Radiographic image of field specimen No 5-Auxiliary steam piping HRSG1 Slag inclusion and cluster porosity

F26	083	0-9	ASME B31.3	C/S	Ø8" x 8,18 mm	Porosity	Repair
F26	083	9 - 18	ASME B31.3	C/S	Ø8" x 8,18 mm	Burn Through	Repair
F26	083	18 - 0	ASME B31.3	C/S	Ø8" x 8,18 mm	Cluster Porosity	Repair
F27	013	0 - 9	ASME B31.3	C/S	Ø8" SCH 40	Incomplete Fusion	Repair
F27	013	9 - 18	ASME B31.3	C/S	Ø8" SCH 40	Cluster Porosity 1 mm	Accepted
F27	013	18 - 0	ASME B31.3	C/S	Ø8" SCH 40	Incomplete Fusion	Repair
F28	013	0 - 9	ASME B31.3	C/S	Ø6" SCH 40		Accepted
F28	013	9 - 18	ASME B31.3	C/S	Ø6" SCH 40		Accepted
F28	013	18 - 0	ASME B31.3	C/S	Ø6" SCH 40	Slag Inclusion and Cluster Porosity	Repair

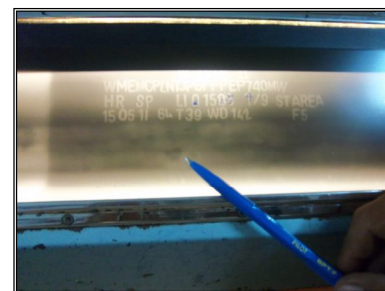
Figure 8. Radiographic image of field specimen No 6-Hot reheat steam piping HRSG1

Joint No	Welder stamp No	Film Location	Standard	Material	Thickness	Weld Defect	Remark
F06	160/161	0 - 12	ASME VIII DIV 1	SA 106 B	Ø26" 39 mm		Accepted
F06	160/161	12- 24	ASME VIII DIV 1	SA 106 B	Ø26" 39 mm	Cluster Porosity 6 mm	Accepted
F06	160/161	24 - 36	ASME VIII DIV 1	SA 106 B	Ø26" 39 mm	Slag Inclusion (3 mm)	Accepted
F06	160/161	36 - 48	ASME VIII DIV 1	SA 106 B	Ø26" 39 mm	Slag Inclusion and Cluster Porosity	Repair
F06	160/161	48 - 60	ASME VIII DIV 1	SA 106 B	Ø26" 39 mm		Accepted
F06	160/161	60 - 72	ASME VIII DIV 1	SA 106 B	Ø26" 39 mm	WH	Repair
F06	160/161	72 - 0	ASME VIII DIV 1	SA 106 B	Ø26" 39 mm	Incomplete Penetration	Repair

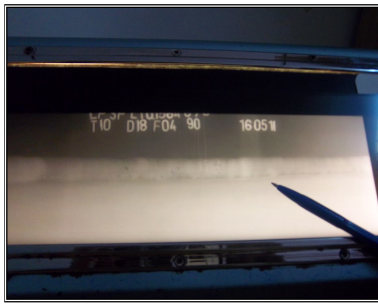
Figure 9. Radiographic image of field specimen No 7-LP steam piping slag inclusion and worm holes

Joint No	Welder stamp No	Film Location	Standard	Material	Thickness	Weld Defect	Remark
F04	090	0 - 12	ASME VIII DIV 1	SA 672 GRB	Ø18" 10 mm	Slag Inclusion & WH	Repair
F04	090	12 - 24	ASME VIII DIV 1	SA335 P12	Ø18" 10 mm	Incomplete Fusion	Repair
F04	090	24 - 36	ASME VIII DIV 1	SA335 P12	Ø18" 10 mm		Accepted
F04	090	36 - 48	ASME VIII DIV 1	SA335 P12	Ø18" 10 mm		Accepted
F04	090	48 - 0	ASME VIII DIV 1	SA335 P12	Ø18" 10 mm	Porosity	Repair
F06	080	0 - 12	ASME VIII DIV 1	SA335 P12	Ø18" 10 mm		Accepted
F06	080	12 - 24	ASME VIII DIV 1	SA335 P12	Ø18" 10 mm	Slag Inclusion	Repair
F06	080	24 - 36	ASME VIII DIV 1	SA 106 C	Ø18" 10 mm	Cluster Porosity	Repair
F06	080	36 - 48	ASME VIII DIV 1	SA 106 C	Ø18" 10 mm		Accepted
F06	080	48 - 0	ASME VIII DIV 1	SA 106 C	Ø18" 10 mm	Slag Inclusion (4mm) and Cluster Porosity (1mm)	Accepted

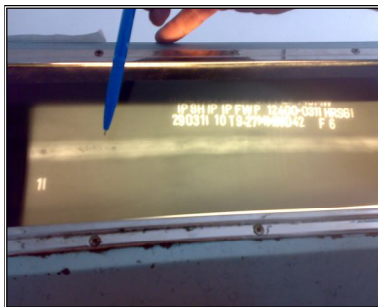
Figure 10. Radiographic image of field specimen No 8 - IP super heater inlet pipe & IP feed water pipe-worm holes

From figure 10 and table 11, it could be seen that the worm hole (WH) occurred at joint No F06 of specimen No 8. This specimen is the IP Super Heater Inlet Piping HRSG1 that is made from SA 106 B. It's diameter and thickness are 10 inch and 9,27 mm respectively. The worm hole is a form of pores that is roughly elliptical in shape and has its major axis normal to the advancing solidification wave. Where irregular shaped voids are present or where cavities occur in group, these are perhaps due to mechanical entrapped gas caused by arc instability.

Joint No	Welder stamp No	Film Location	Standard	Material	Thickness	Weld Defect	Remark
F06	042	0 - 11	ASME VIII DIV 1	SA 106 B	Ø10" 9,27 mm	Worm Holes	Repair
F06	042	11 - 22	ASME VIII DIV 1	SA 106 B	Ø10" 9,27 mm	Worm Holes	Repair
F06	042	22 - 0	ASME VIII DIV 1	SA 106 B	Ø10" 9,27 mm		Accepted
F07	42/67	0 - 11	ASME VIII DIV 1	SA 106 B	Ø10" 9,27 mm	Porosity 1 mm	Accepted
F07	42/67	11 - 22	ASME VIII DIV 1	SA 106 B	Ø10" 9,27 mm		Accepted
F07	42/67	22 - 0	ASME VIII DIV 1	SA 106 B	Ø10" 9,27 mm	Incomplete Fusion	Repair
