## FAILURE ANALYSIS OF ALUMINIUM AND ZINC HEAT REFLECTOR IN TIMBER DRY KILN

Aluminium and Zinc (Al-Zn) alloy coated steel sheet (JIS G3141) was used as a heat reflector in timber dry kiln. After six months continuous service at 110°C in moist condition, the heat reflector is corroded. Failure analysis method was used to analyze this corrosion phenomena. Macroscopic and microscopic examination with some characterization have been performed to determine the elemental composition and corrosion products. The elemental composition of corroded heat reflector that were detected by SEM-EDS are sulphur, chloride, calcium, and potassium. XRD analysis revealed the zinc aluminium carbonate hydroxide hydrate ( $Zn_6Al_2(OH)_{16}CO_3 \cdot 4H_2O$ ) known as black rust staining and iron oxide ( $Fe_3O_4$ ), as corrosion products. Environmental condition in timber dry kiln with the existence of acid and alkaline elements cause the corrosion process occur. Those elements come from the dried timber and steam that adhered on the heat reflector surface attacked the Al-Zn coating and base metal. Humidity and high temperature in timber dry kiln environment increase the corrosion rate of the heat reflec

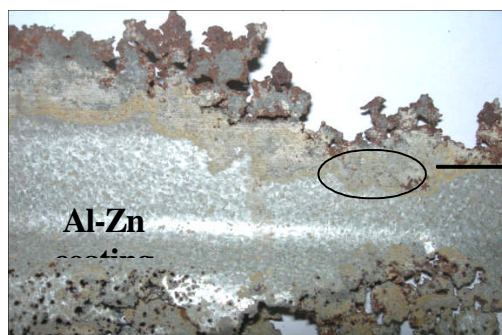
The temperature of the kiln is 110 °C and the kiln was operated in 24 hours non stop. Aluminium and Zinc (Al-Zn) alloy in this kiln to function as a sub ceiling. This ceiling was used as a heat reflector in order to isolate the heat and the heat can be reflected back to the timber. Kind of wood that was dried in timber dry kiln is Sengon wood. After six months continuous service, the Al-Zn heat reflector was corroded and rusty. Figure 1 showing the corroded and rusty Al-Zn alloy that was used as heat reflector.

Figure 1. The corroded Al-Zn heat reflector.
