**GROUND PENETRATING RADAR SURVEY ACROSS
THE BOK BAK FAULT, KEDAH, MALAYSIA***Yuniarti Ulfa, Nur Fathin Mohd Jamel, Mardiana Samsuardi*

GROUND PENETRATING RADAR SURVEY ACROSS THE BOK BAK FAULT, KEDAH, MALAYSIA. A ground penetrating radar (GPR) survey was done across the Bok Bak Fault zone in Baling, Kedah in order to investigate the shallow subsurface geology of the Bok Bak fault zone, its extension and associated weak zones within the study area. GPR data acquisition was compared with visual inspection on the slope of the outcrop. Ten GPR profiles were acquired using 250 MHz GPR frequency. Basic data processing and filtering to reduce some noise and unwanted signal was done using MALA RAMAC Ground Vision software. The data penetrate around 2 meters in depth for all survey lines. In most lines shows clear images of shallowest Bok Bak Fault (NW trending) as detected at distance of 28 m horizontal marker. It also exhibits several sets of faults as a result of Bok Bak Fault deformation, including the conjugate NE trending fault (Lubok Merbau Fault). Active seismicity encompasses the Malay-Thai Peninsular trigger the changes of Bok Bak Fault dipping direction, steeper dips of conjugat

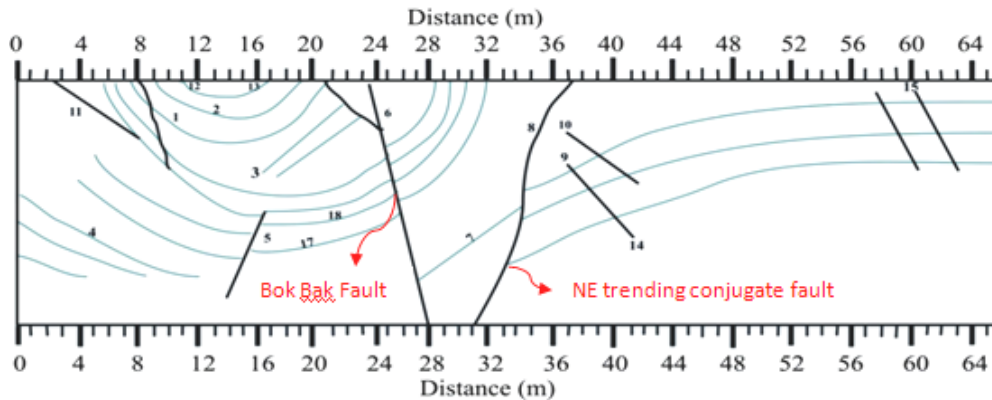
Figure 4. Field sketch for the direct (visual) slope observations on the faults, fold, and joints as a result of Bok Bak Fault deformation.

In general, 250 MHz antenna frequency can provide the radargram data around 2 meters in depth for all survey lines. The resolution of data is good as the anomaly can be seen clearly. In most lines profile show clear images of shallowest Bok Bak Fault (NW trending) as detected on distance 28 m. It also exhibit several sets of faults as a result of Bok Bak Fault deformation, including the conjugate NE trending fault (Lubok Merbau Fault) as shown by the visual inspection on the rock-slope outcrop (Figure 4).
